UNDERWATER FACILITIES AND INSPECTIONS AND ASSESSMENTS

NAVAL AIR STATION

PENSACOLA, FLA.

JANUARY 1983

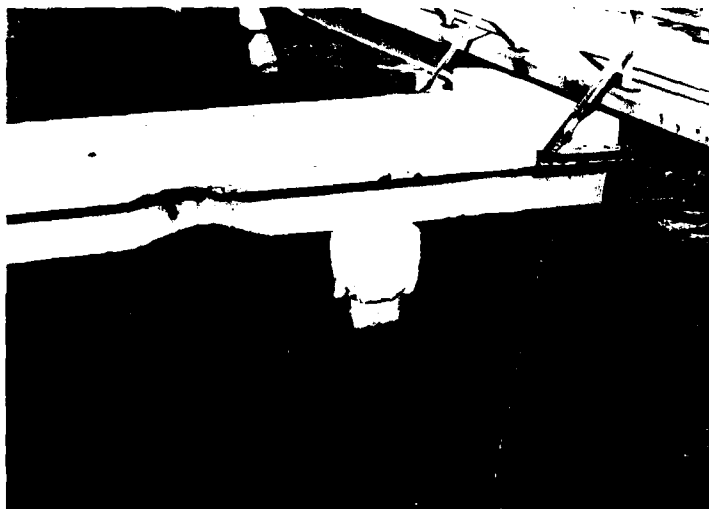
PHOTO NO. 18

Pier 3238 - Spalled edge of pile cap and
spalled deck unit at Bent 9.

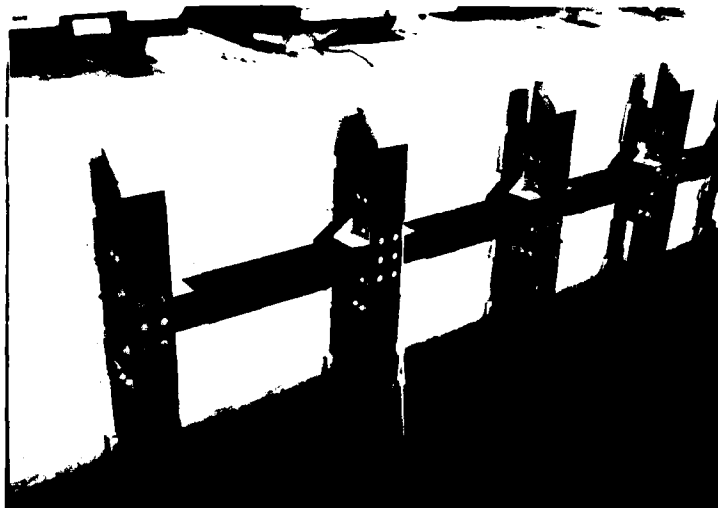
PHOTO NO. 47

Pier 302 - Typical view of concrete encasement in excellent condition above waterline.

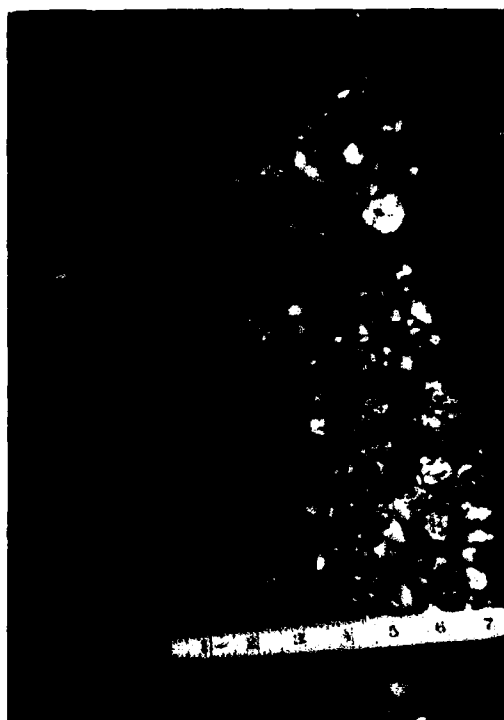
PHOTO NO. 54

Bulkhead 708B - Joint spall at station 1+10

With the repair of the joints and repair of the pavement and toe (as deemed necessary by further inspection) the expected life of the seawall is 25 years. Without these repairs the expected life is less than 5 years - during which time the pavement is expected to fail due to loss of material from behind the wall. The estimated cost of the joint (seal) repairs is \$10,000 (see Appendix D).
